Open Eye Home Inspections LLC

Property Mold Inspection Report

Property address: **Sample**

Inspection date: **Monday, May 13, 2024**

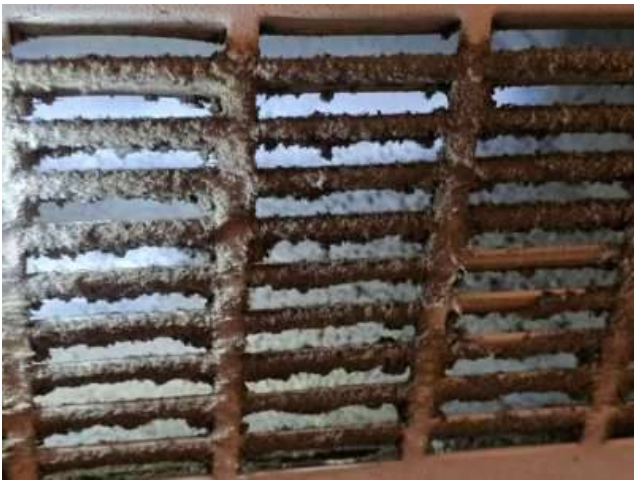
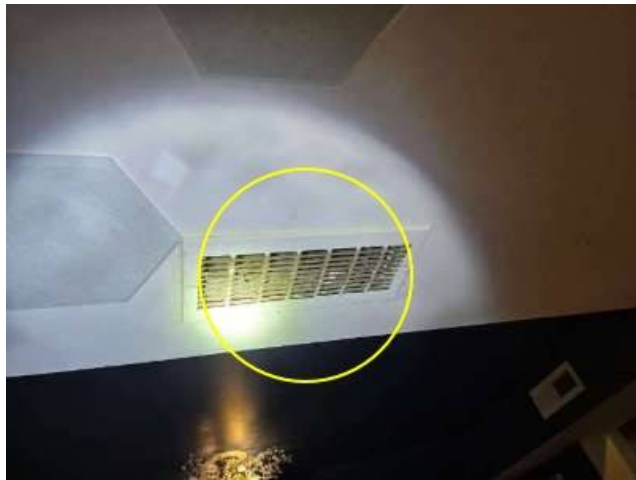
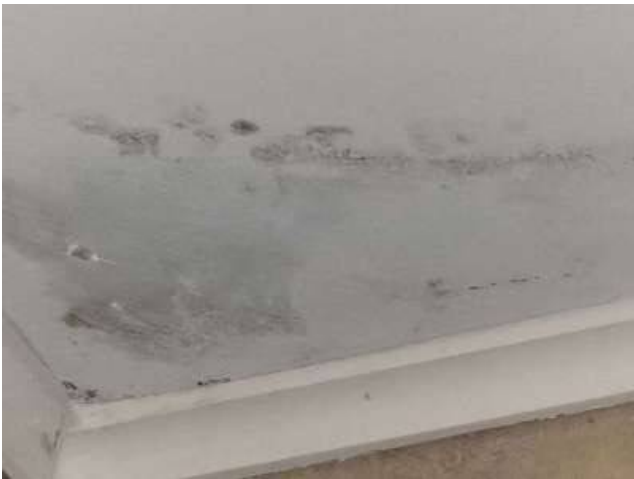
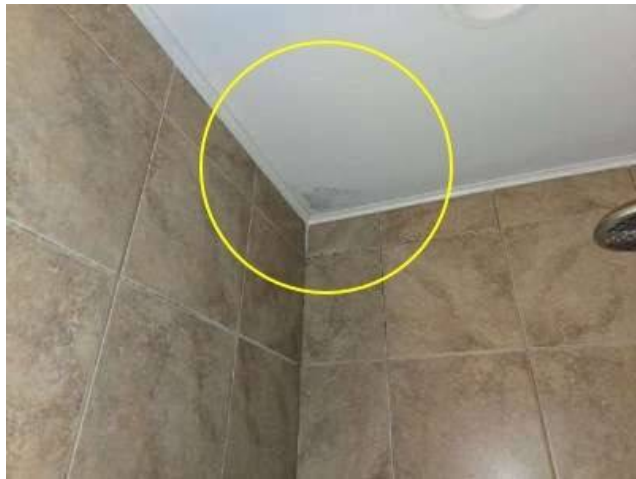
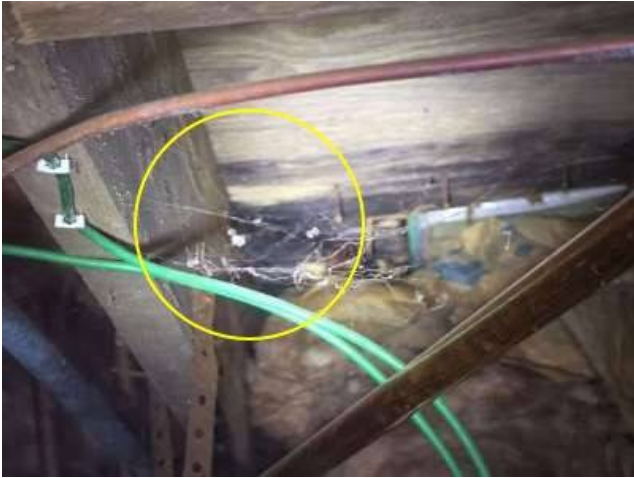
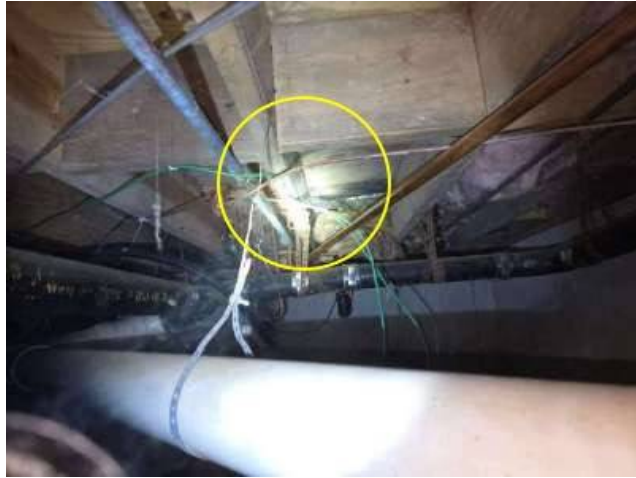
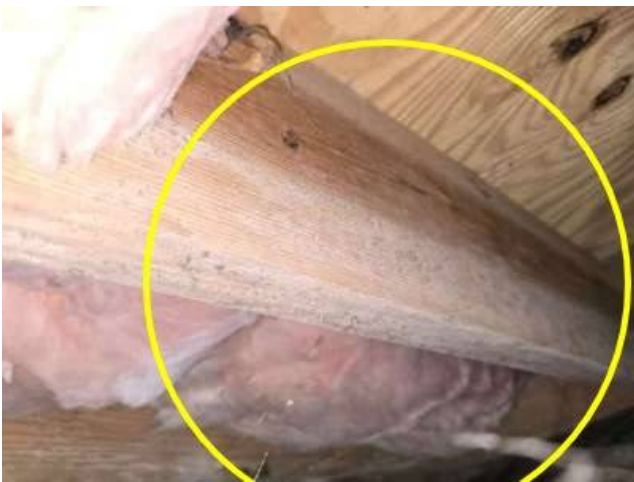
Microbial growths were found at one or more locations in interior rooms, bathroom and/or the crawl space. A mold test was performed, and the results are added to the email for this report. Such staining is normally caused by excessively moist conditions, which in turn can be caused by plumbing or building envelope leaks and/or substandard ventilation. These conducive conditions should be corrected before making any attempts to remove or correct the staining. Normally affected materials such as drywall are removed, enclosed affected spaces are allowed to dry thoroughly, a mildewcide may be applied, and only then is drywall reinstalled. For evaluation and possible mitigation, consult with a qualified industrial hygienist or mold/moisture mitigation specialist. For more information, visit:

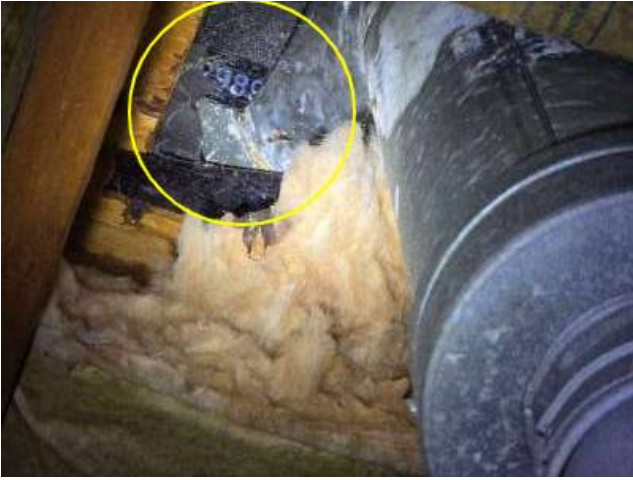
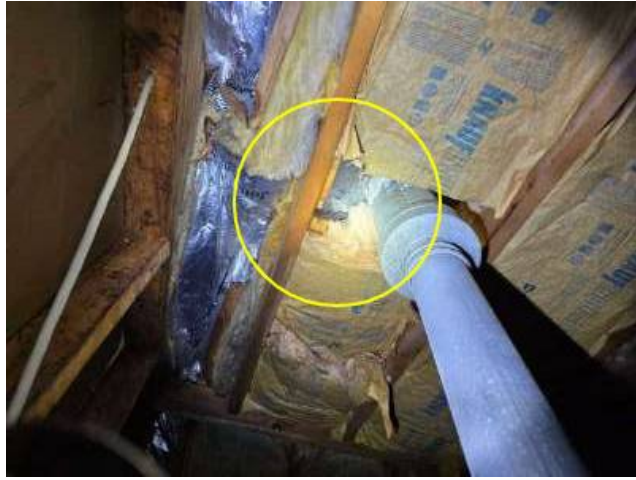
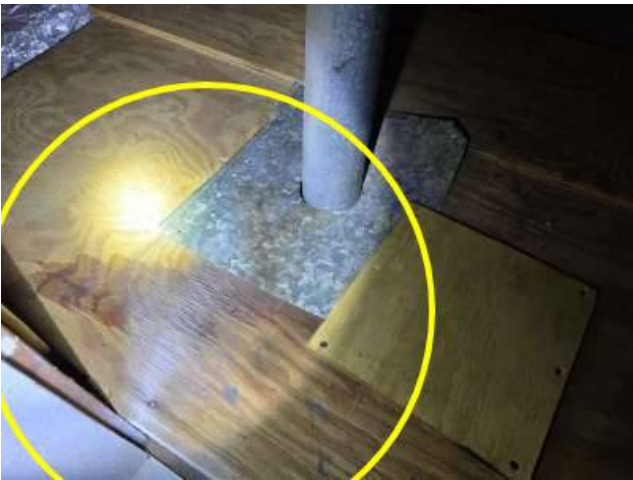
While inspecting the attic area, the inspector noticed an active leak from the metal exhaust duct that exits the attic in this area by the hatch. Moisture on the interior of the structure can contribute to microbial growth. Recommend having a qualified contractor evaluate and make all necessary repairs.

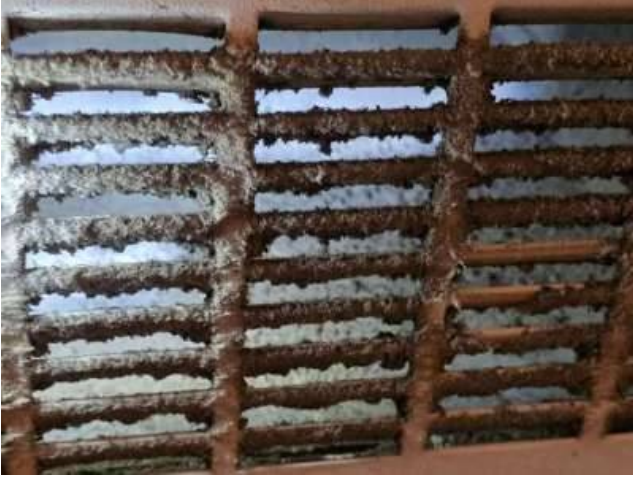
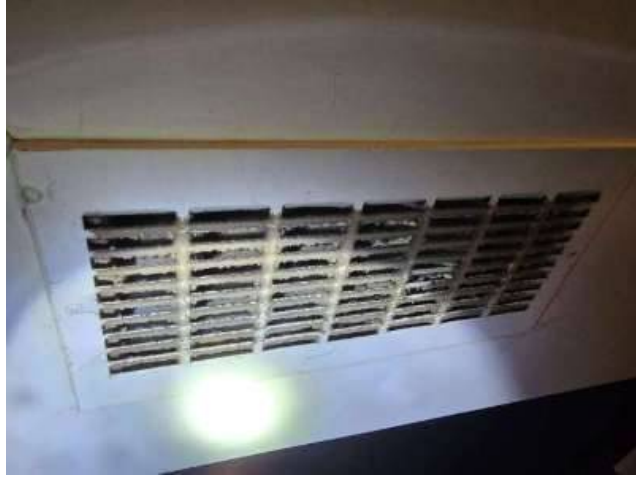
Significant amounts of debris, dirt and/or dust were visible in one or more sections of supply and/or return air ducts for the heating or cooling system. This can be a health hazard, especially for those with allergies or respiratory problems. The Environmental Protection Agency (EPA) recommends considering having ducts professionally cleaned when "ducts are clogged with excessive amounts of dust and debris and/or particles are actually released into the home from your supply registers." This can contribute to the spreading microbial growth. Recommend that a qualified contractor clean the ducts. For more information on duct cleaning in relation to indoor air quality, visit:

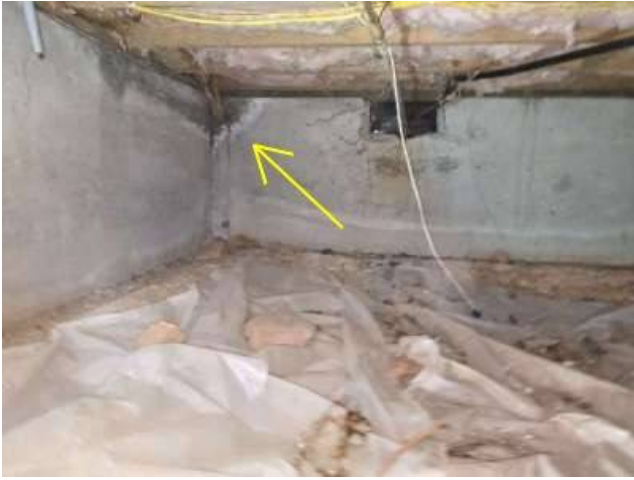
Photo 6-1

Evidence of prior water intrusion or accumulation was found in one or more sections of the crawl space. For example, sediment stains on the vapor barrier or foundation, and/or efflorescence on the foundation. Accumulated water is a conducive condition for wood-destroying organisms and should not be present in the crawl space. It can contribute to microbial growth. The crawl space should be monitored in the future for accumulated water, especially after heavy and/or prolonged periods of rain. If water is found to accumulate, then recommend that a qualified contractor who specializes in drainage issues evaluate and repair as necessary. Typical repairs for preventing water from accumulating in crawl spaces include:

- Repairing, installing or improving rain run-off systems (gutters, downspouts and extensions or drain lines)
- Improving perimeter grading
- Repairing, installing or improving underground footing and/or curtain drains

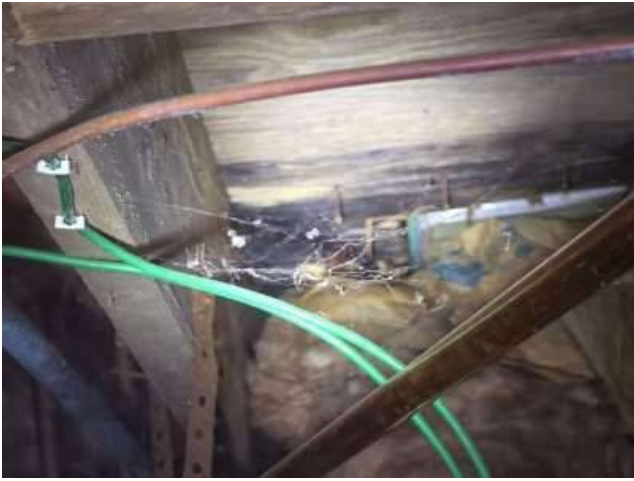
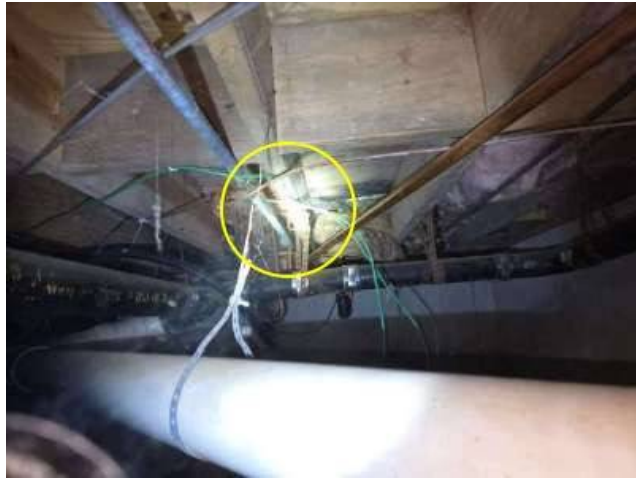
Damage and microbial growth were observed in the crawlspace below the main floor bathroom. Recommend having a qualified contractor evaluate and make any necessary repairs.

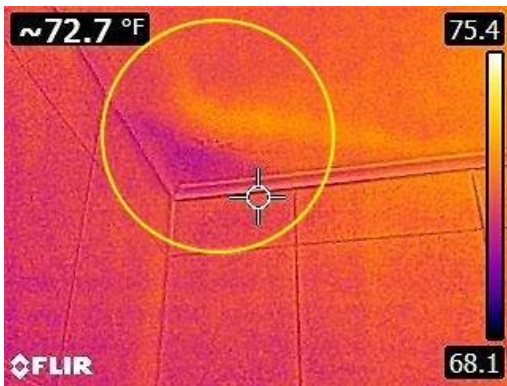
Microbial growth was observed in the main floor bathroom ceiling above the shower. Recommend having a qualified contractor evaluate and make any necessary repairs.

Photo 8-3 THE INFRARED SCAN SHOWS A TEMPERATURE ANOMALY INDICATING MOISTURE IN THIS AREA.
